Bats in Buildings

Guidance Notes for:

Planners, engineers, architects and developers

December 2010

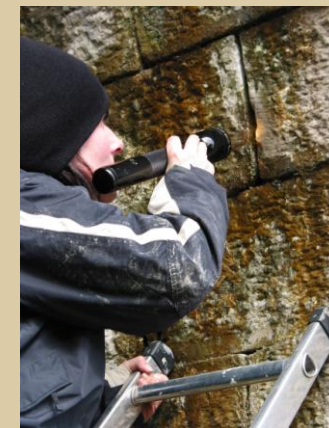
Crevices should be checked by using a high powered narrow beam torch light or an endoscope. A single soprano pipistrelle was found in this crevice.

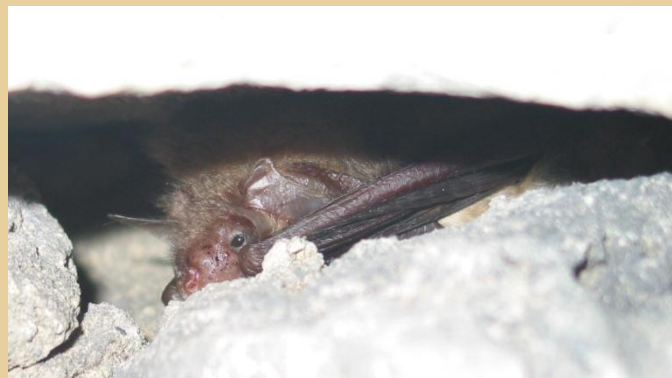
Lesser horseshoe bats (above) hang openly and therefore are visible within the roost. All other Irish bat species are crevice-dwelling bats and often secrete themselves away such as the brown long-eared in the photograph below. This bat is roosting within a stone crevice adjacent to a door frame.

Below: brown long-eared bat in crevice (Photos: Tina Aughney)

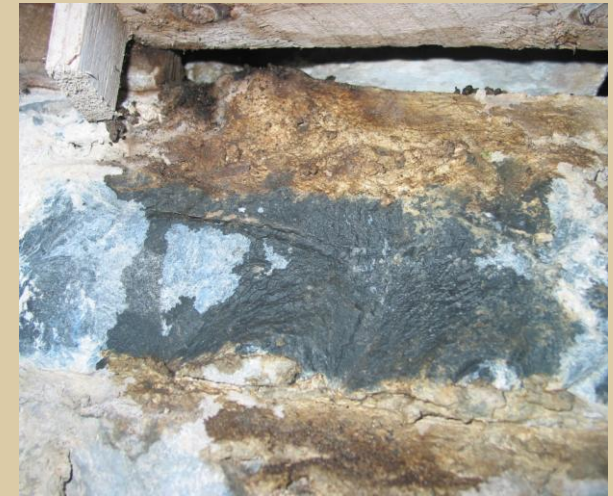
What does bat urine staining look like?

This staining (indicated by arrows) is often present in a regularly used roosting site.

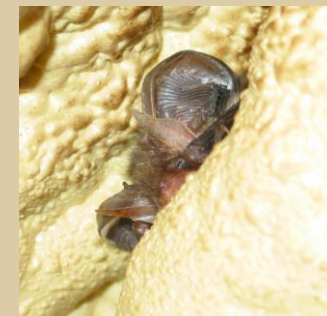
Visible bats: a brown long-eared bat is tucked into a crevice in foam insulation in an attic space

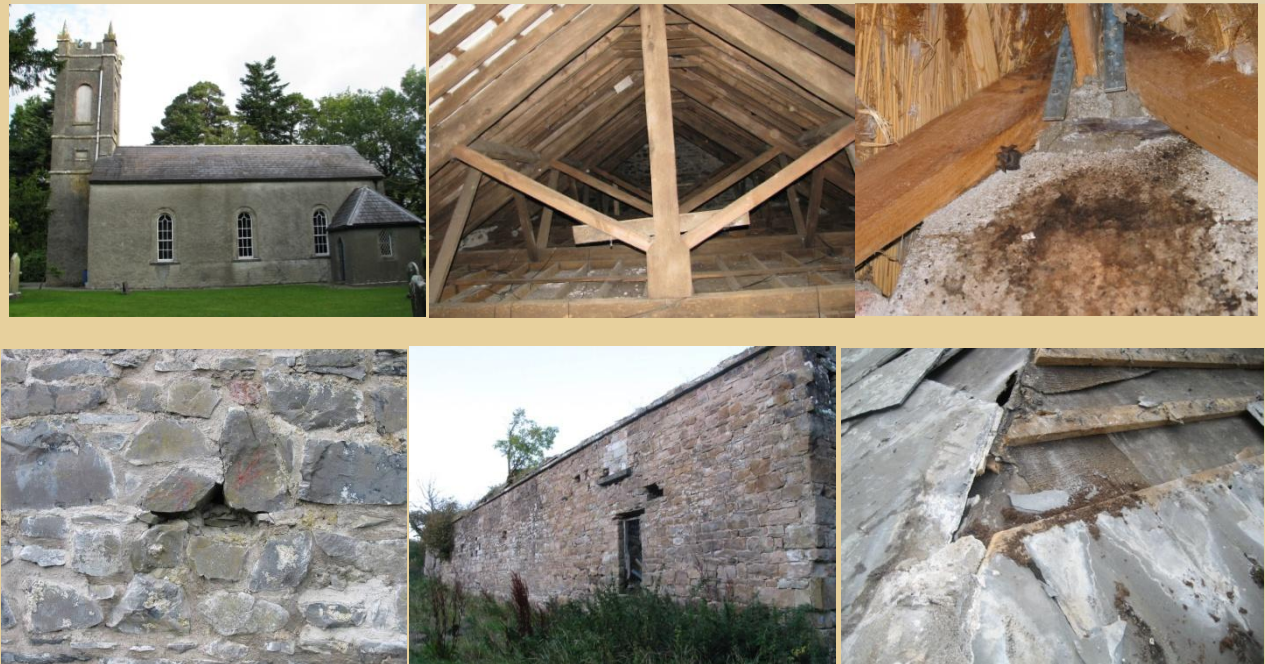
Above: examples of typical bat roosting sites – churches, large roof spaces, gaps between roof beams and gable wall, crevices in stonework, stone buildings and spaces between roof felt and slates. (Photos: Tina Aughney & Paul Scott)

Common roosting sites in buildings used by Irish bat species

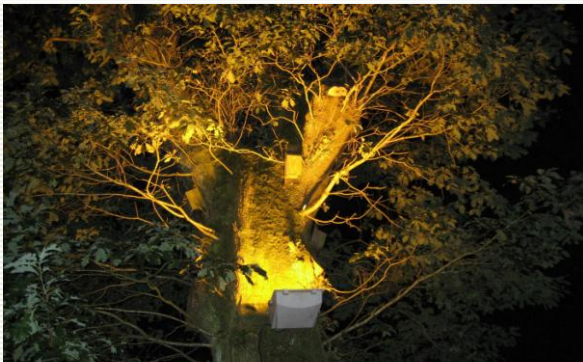
Example of poor lighting – flood lights on tree will prevent bats from using tree and bat boxes (Photo: Austin Hopkirk)

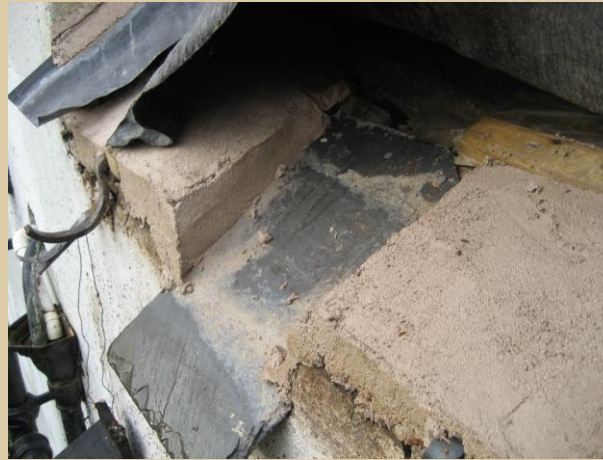
Description of Works Completed: Bat access slits were fitted into the locations of previously recorded access points. The new battens have been designed to allow bats to wriggle out of their roosting space within the attic and find their way to the exit points. The overhanging slate acts as baffle to reduce the amount of droppings sticking on the wall below and also acts a landing point for the hundreds of soprano pipistrelle bats that use this roost.

Top: Position of slate prior to the instalment of roof felt.

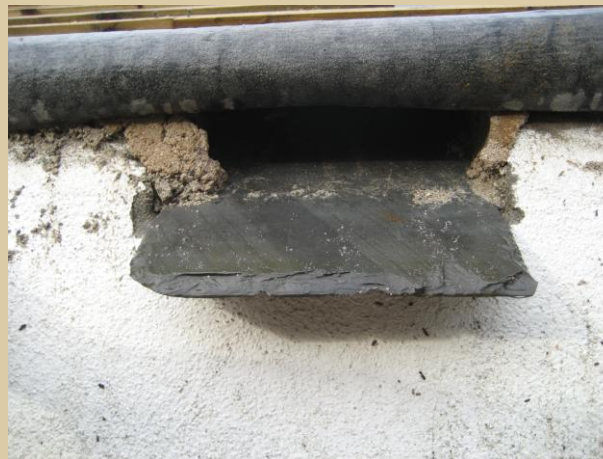
Middle: View of slate access point from exterior wall of building.

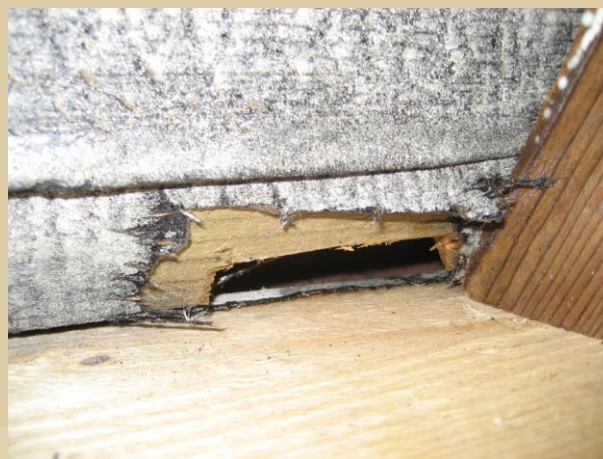
Bottom: View of access point within the attic space itself.
